EFFECT OF THERMAL RADIATION ON THE INTEGRITY OF PRESSURIZED AIRCRAFT EVACUATION SLIDES AND SLIDE MATERIALS

FINAL REPORT

MARCH 1981

Prepared for
**U. S. DEPARTMENT OF TRANSPORTATION
FEDERAL AVIATION ADMINISTRATION
TECHNICAL CENTER
Atlantic City Airport, N.J. 08405**

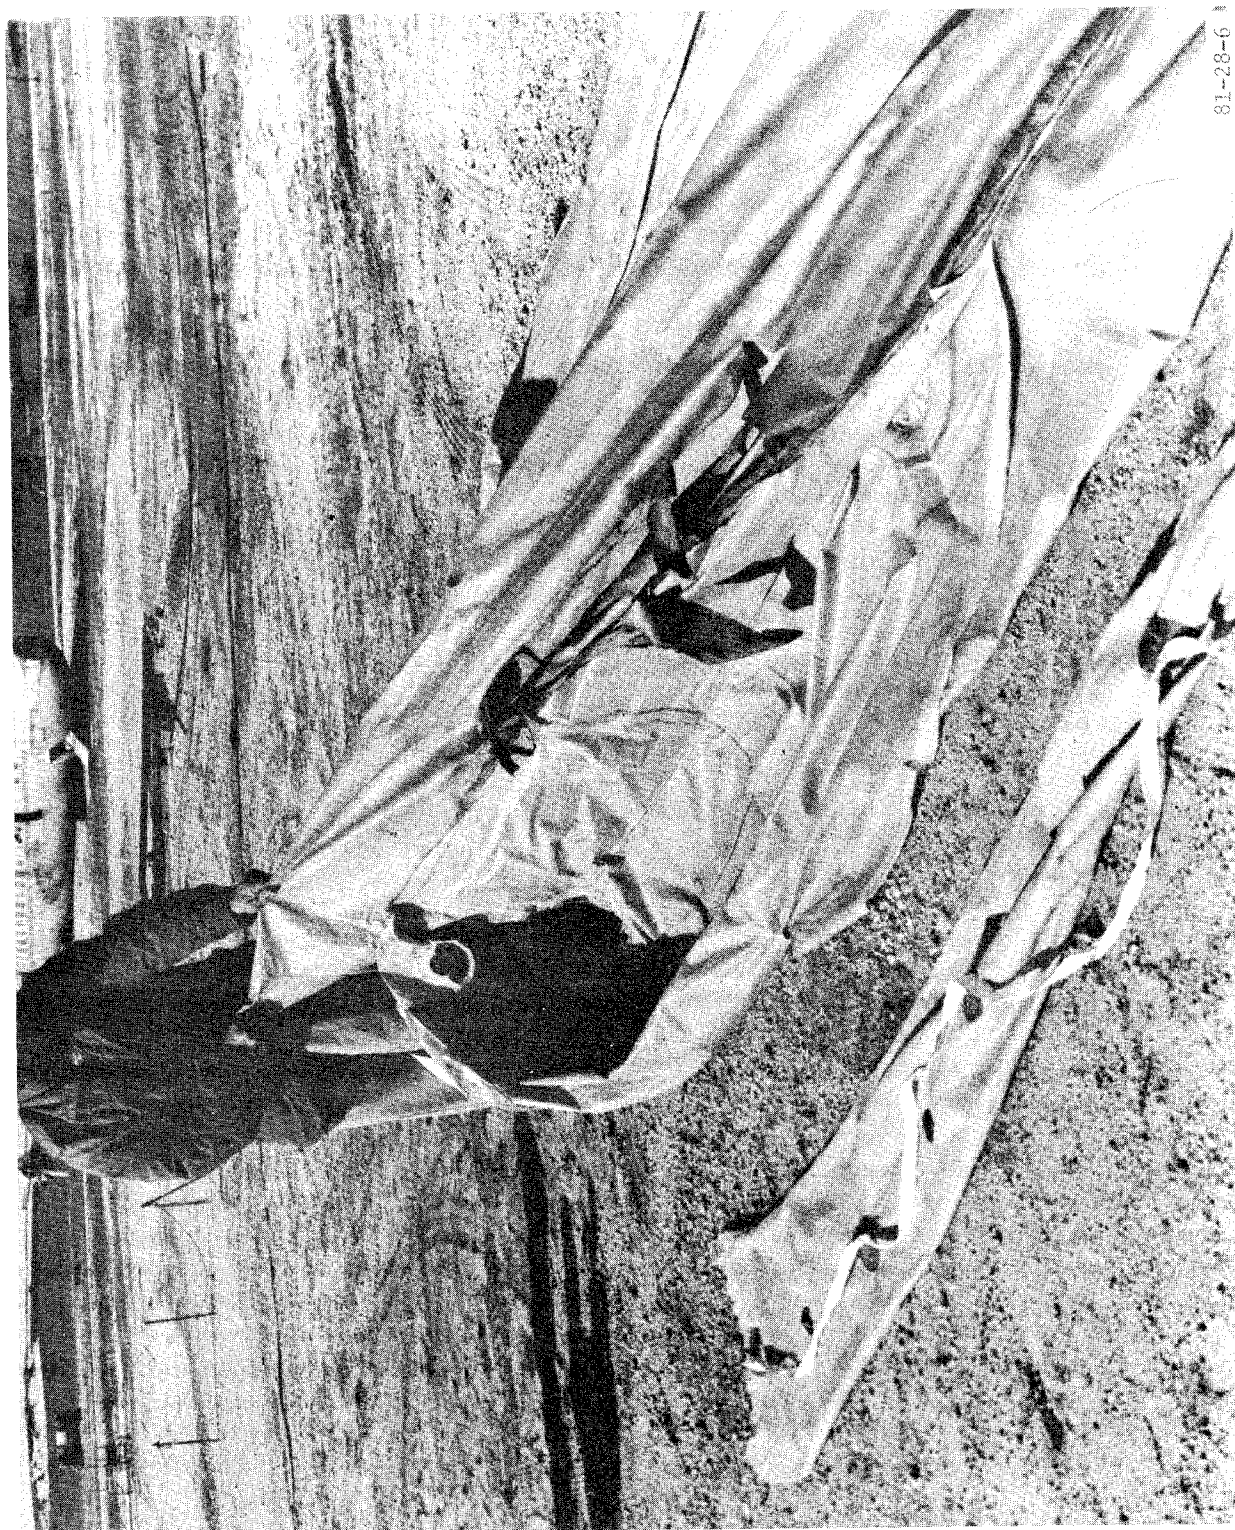
FIGURE 7. NEOPRENE NYLON SEAM FAILURE; TEST 11

At 58 seconds into the test, the upper chamber blew out catastrophically on a seam area facing the fire near the base of the slide. The blowout shifted the base of the slide approximately 3 feet further away from the fire pit. Also at 58 seconds, the lower chamber began losing pressure, perhaps from the shock caused by failure of the upper chamber. The loss of pressure was very gradual (figure B-9) in contrast to the experiences of previous tests. By 206 seconds, the lower chamber had leaked down from a peak pressure of 3.75 psig at 58 seconds to 3.25 psig, and blew out catastrophically on a seam area near the base of the slide (see figure 7). The medium height calorimeter recorded the peak heat flux and the highest average heat flux, 1.4 Btu/ft²-sec and 1.16 Btu/ft²-sec, respectively. It was estimated that the heat flux near the base of the slide dropped approximately 0.3 Btu/ft²-sec after failure of the upper chamber.

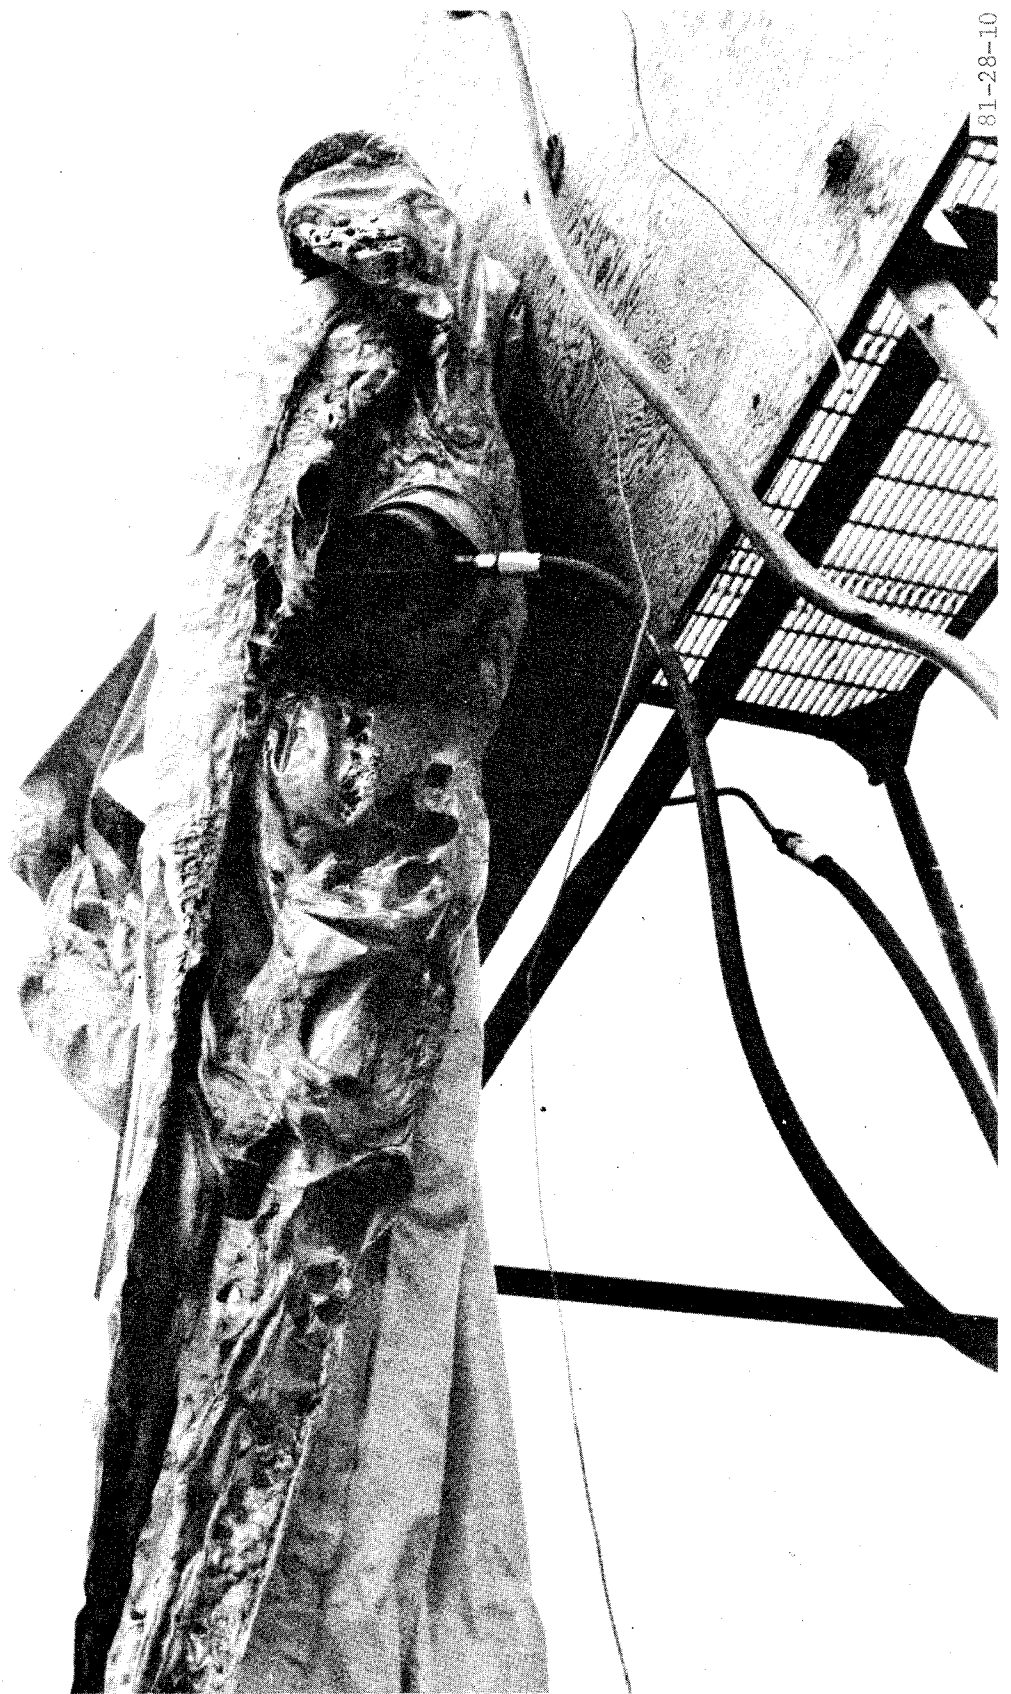
FIGURE 11. URETHANE NYLON NONSEAM FAILURE; TEST 16A

middle of the tube facing the fire. By 64 seconds, at a pressure of 0.5 psig, the uncoated slide blew out in a nonseam area approximately 3 feet below the aspirator on the tube facing the fire (see figure 11). The measured radiative heat flux levels are shown in figure B-12. Although the heat flux values are slightly less than in test 3, which also exposed a double-lane urethane nylon slide at 15 feet from the fire, the onset of failure from this test is consistent with test 3.

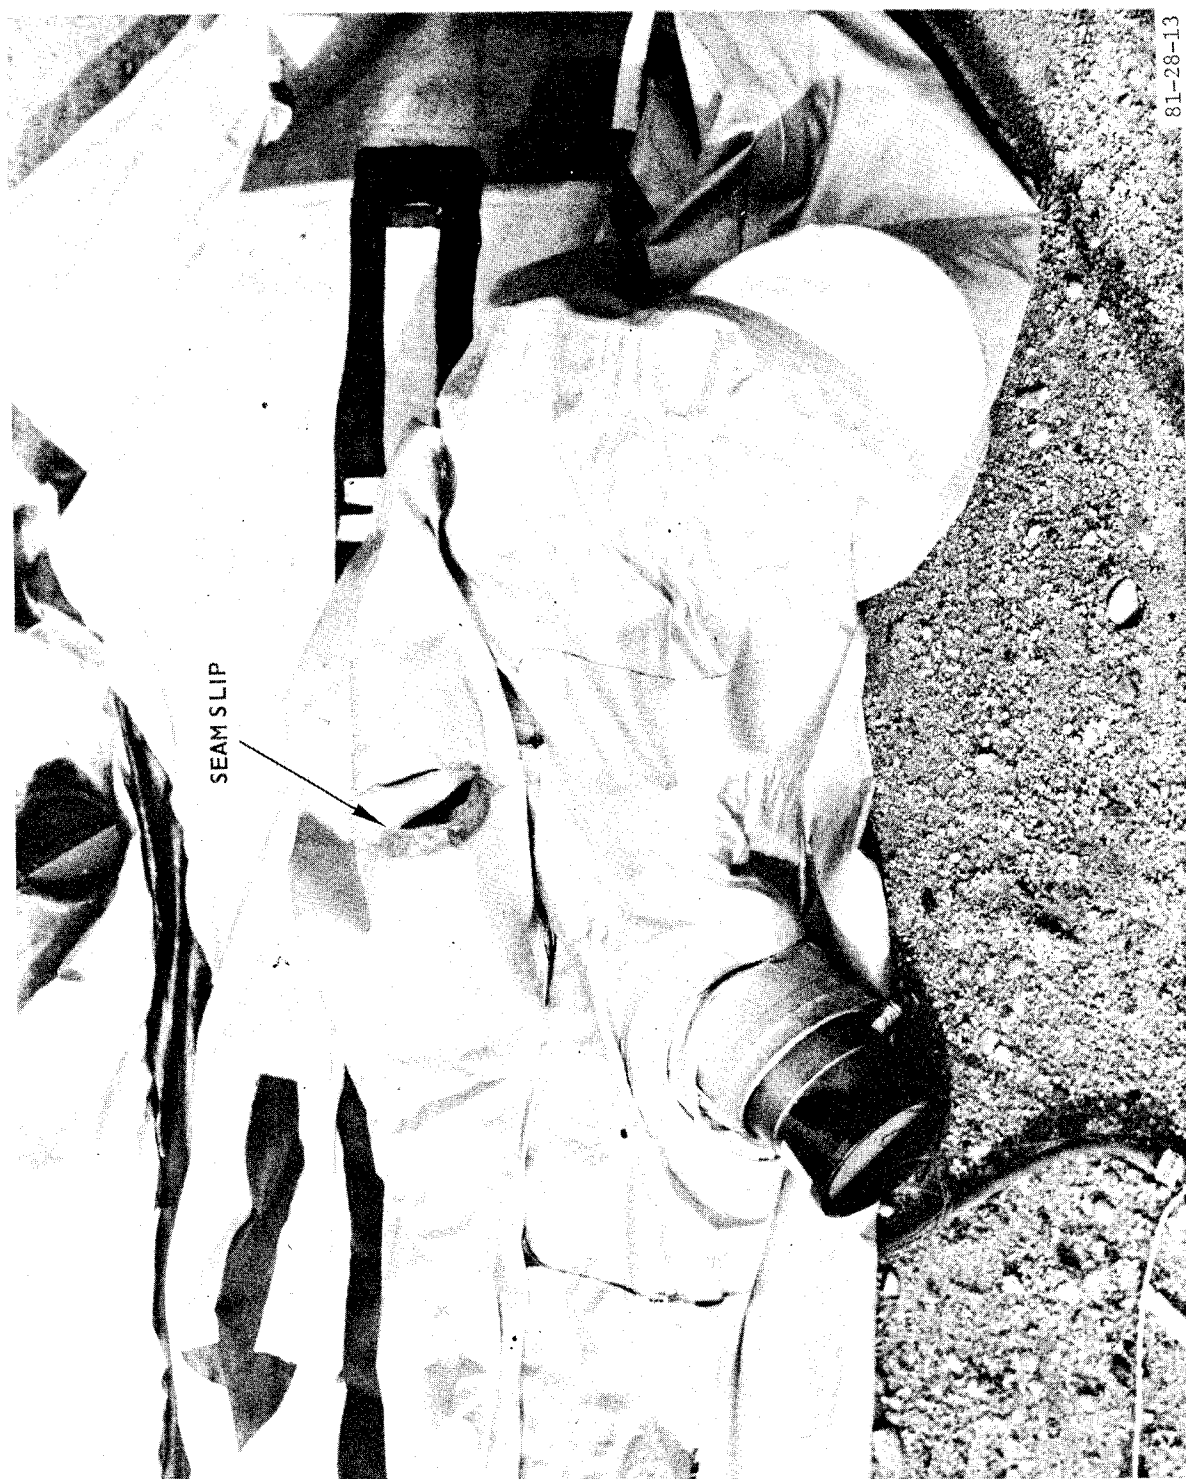
FIGURE 14. ALUMINIZED URETHANE NYLON SEAM SLIPPAGE; TEST 19

At 58 seconds into the test, seam slippage occurred near the top of the slide on a rounded corner of the upper retaining tube ("armrest") (see figure 14). The slide visually began to collapse at 85 seconds. The peak heat fluxes for the low, medium, and high calorimeters were 1.75 Btu/ft²-sec, 1.65 Btu/ft²-sec, and 1.25 Btu/ft²-sec, respectively (figure B-15). The average heat fluxes for the low, medium, and high calorimeters were 1.2 Btu/ft²-sec, 1.22 Btu/ft²-sec, and 0.85 Btu/ft²-sec, respectively (refer to appendix B-15). This test indicated that seam failure limited the potential heat resistance improvements provided by an aluminized coating applied to a

complete evacuation slide. No visible damage was noted in the nonseam middle and base areas, although the average heat fluxes at these locations were higher than at the top of the slide. The temperature rise for the top side of the sliding surface was 90° F by 58 seconds.

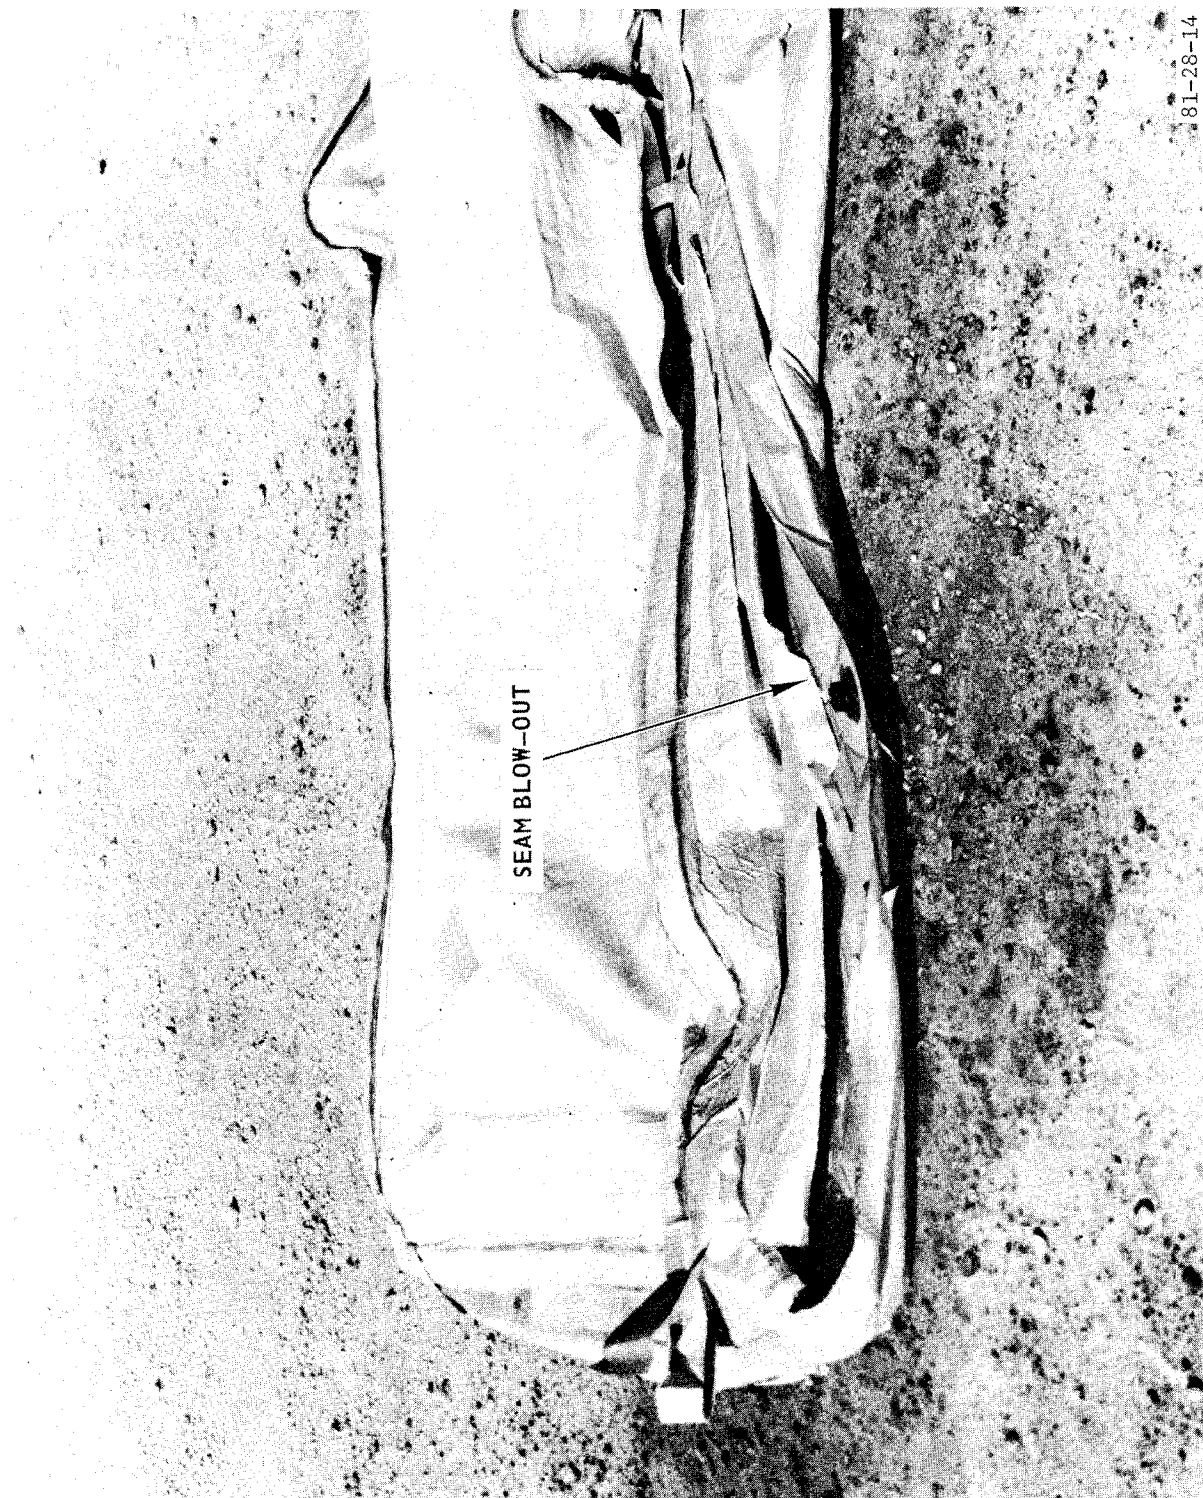
FIGURE 15. ALUMINIZED NEOPRENE NYLON SEAM FAILURE; TEST 20

At 49 seconds into the test, the slide reached a peak pressure of 4.1 psig and blew out catastrophically on a seam near the base of the tube facing the fire (see figure 15). The peak heat fluxes for the low, medium, and high calorimeters were 0.9 Btu/ft²-sec, 0.8 Btu/ft²-sec, and 1.1 Btu/ft²-sec, respectively, all recorded at 45 seconds (figure B-16). At these heat flux levels, it was expected that the aluminized neoprene nylon slide would have resisted the fire for a longer period of time. No visible radiant heat damage was noted in the middle and top areas of the slide, in spite of the highest heat flux levels at the top of the slide. Other seam areas near the base of the slide also showed no visible radiant heat damage. It was therefore concluded that the seam in the failure area contained some sort of flaw. The temperature rise for the top side of the sliding surface was 47° F by 49 seconds.
